# DDASaccident819

Humanitarian Demining Accident and Incident Database  
*AID*

# DDAS Accident Report

<b>Report date:</b> 11/04/2019	<b>Accident number:</b> 819
<b>Accident time:</b> Not recorded	<b>Accident Date:</b> 20/01/2019
<b>Where it occurred:</b> MASAM compound, Marib City, Marib governate	<b>Country:</b> Yemen
<b>Primary cause:</b> Field control inadequacy (?)	<b>Secondary cause:</b> Inadequate training (?)
<b>Class:</b> Handling accident	<b>Date of main report:</b> 21/01/2019
<b>ID original source:</b>	<b>Name of source:</b> Press/social media
<b>Organisation:</b> [Name removed]	
<b>Mine/device:</b> AT (unrecorded)	<b>Ground condition:</b> hard; residential/urban
<b>Date record created:</b>	<b>Date last modified:</b> 11/04/2019
<b>No of victims:</b> 5	<b>No of documents:</b> 1

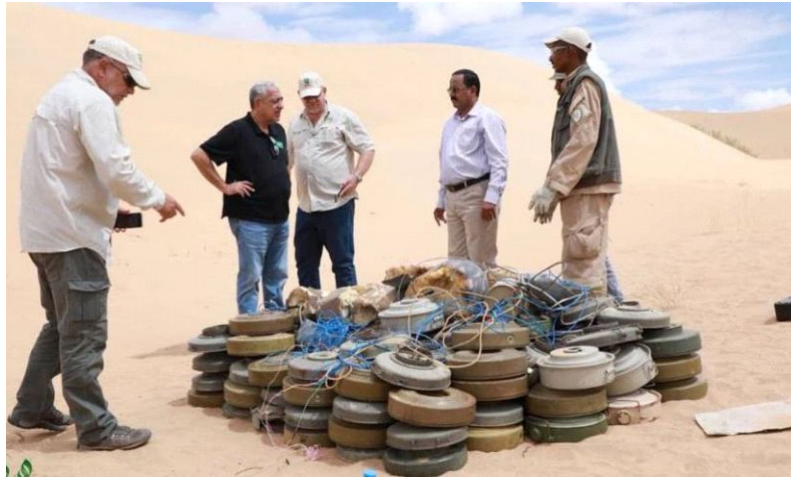
[This photograph apparently shows preparations for a previous demolition. Some mines shown may still be fuzed. The pile appears to have IEDs or IED components on top. No PPE is being worn.]

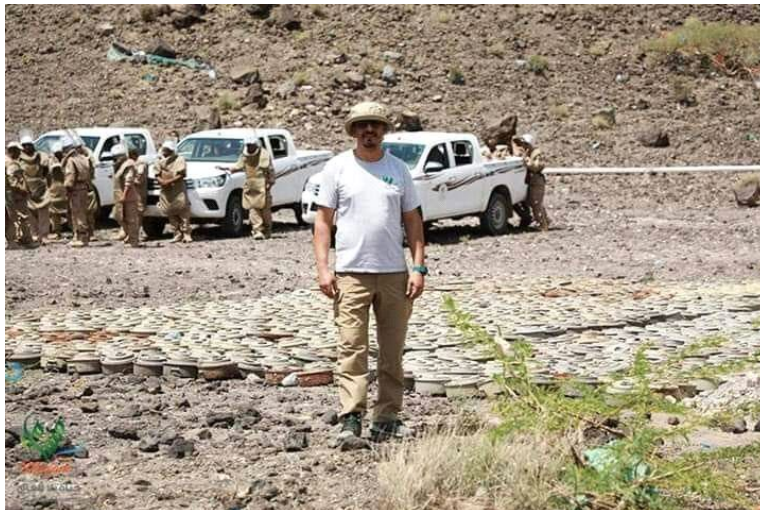
[This picture shows [Victim no.1] in front of hundreds of recovered AT mines, all of which would have been transported in the back of the pick-up trucks behind. As is common, the supervisor is proudly photographed not wearing any PPE.]

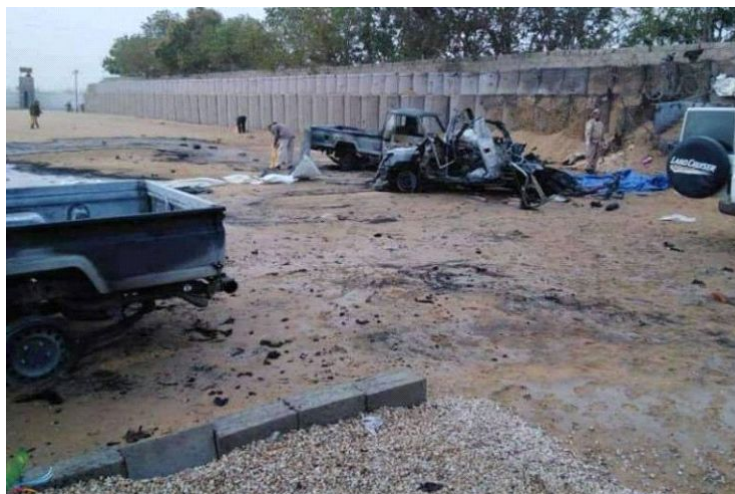
[This picture was taken after the pickup truck top centre has exploded. The blast damage indicates that it occurred in the back of the truck. Two other trucks are wrecked. People

anywhere close by would have been killed by the blast and fragmentation from the metal mine casings and the truck. The blue tarpaulin may conceal body parts.]

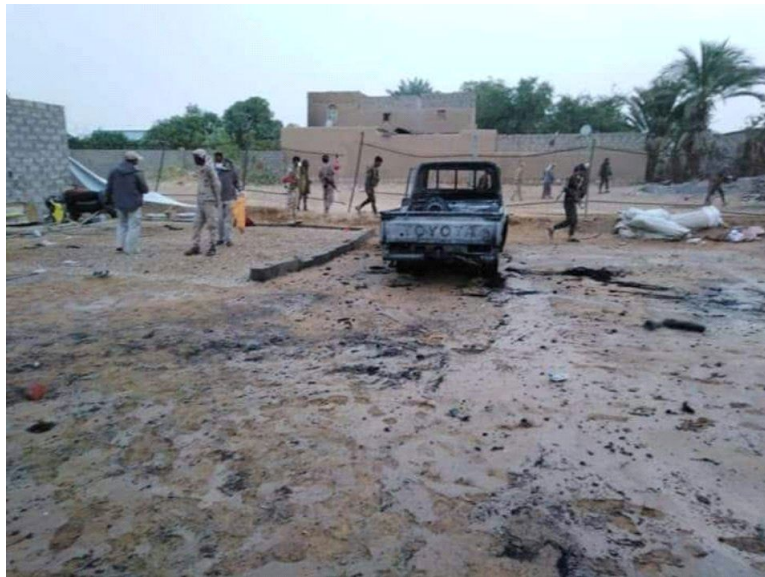
[Another view shows a third burned out pickup truck and seems to confirm that this happened inside a compound, not in transit.]

[From the photographs posted, it can be reliably inferred that the accident happened inside the MASAM compound loading area. Whether the Victims were loading mines or training how to load mines, the mines had not (or not all) had their fuzes removed, or possibly the live fuzes were being transported at the same time. The mines had been recovered from the field and were being transported to a remote place for demolition.]

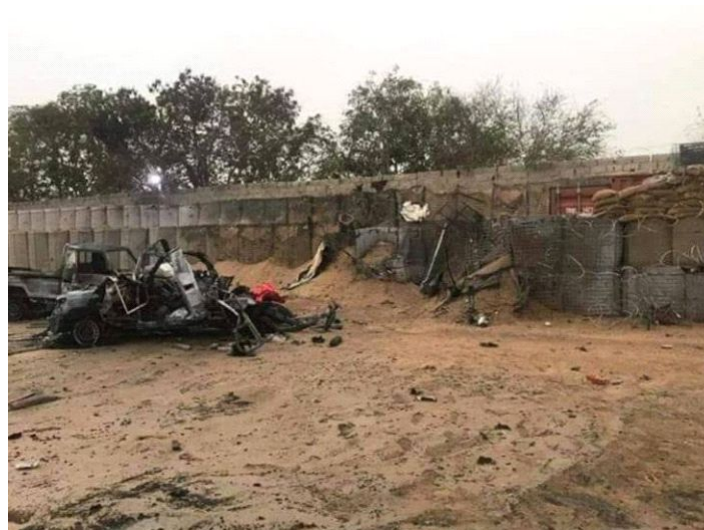
[The storage area for explosives may be behind the protected door on the right.]

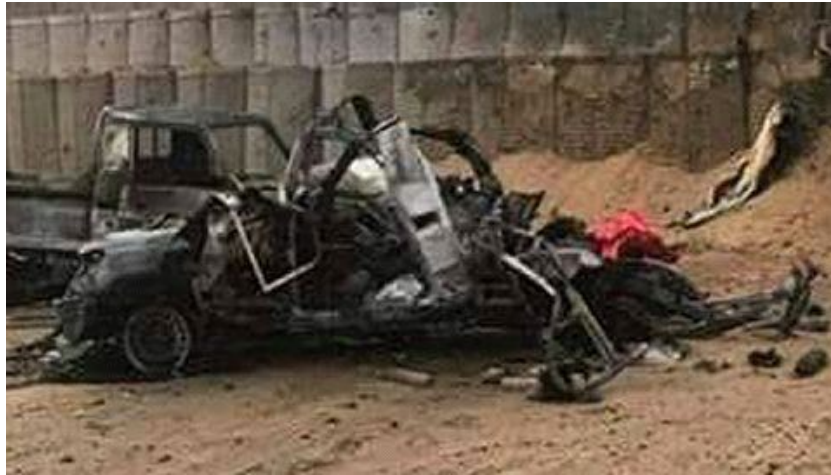
[A major detonation occurred in the back of this truck, destroying the second pickup truck close by. A third pickup truck some 25 metres away caught fire and burned out, which implies a very significant blast or may imply that other munitions, possibly including incendiary materials, were being transported along with the mines.]
